# Manhole Inspection Summary

Manhole # S19AA2012MH

**Location** Address: **1701 MT. WASHINGTON CT**

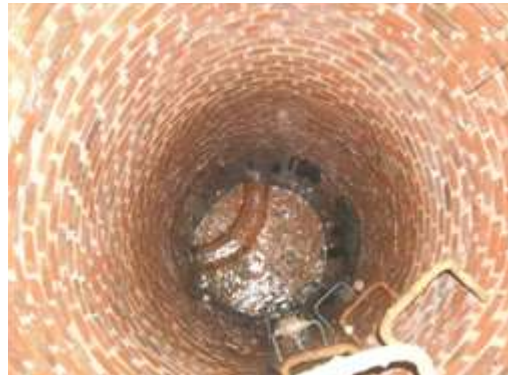
Top View

**Bench** ☒ Exists Material: **Brick** ☐ Parged ☒ **Debris** (not Condition related)

**Steps** Count: **10** Missing: **0** ☒ **Corroded**

Corroded steps. Evidence of surcharge - Bench debris.

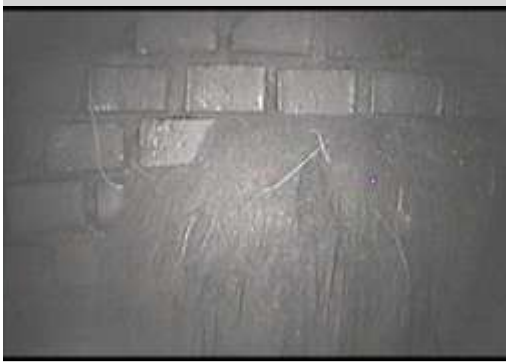
Defect

Condition: ☐ Sound ☐ Cracked ☒ **Root Intrusion** ☐ Loose Brick ☐ Deteriorated

Infiltration: ☐ None ☐ Joint ☐ Cracks ☐ Mortar ☒ **Roots** ☒ **Wall**

Barrel root intrusion and infiltration.

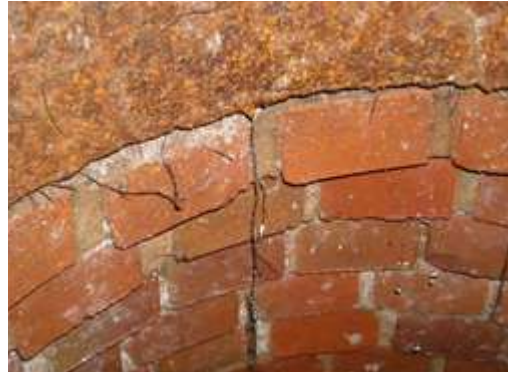
Defect

Condition: ☐ Sound ☐ Cracked ☒ **Root Intrusion** ☐ Loose Brick ☐ Deteriorated

Infiltration: ☐ None ☒ **Joint** ☐ Cracks ☐ Mortar ☒ **Roots** ☐ Wall

Corbel root intrusion and infiltration.

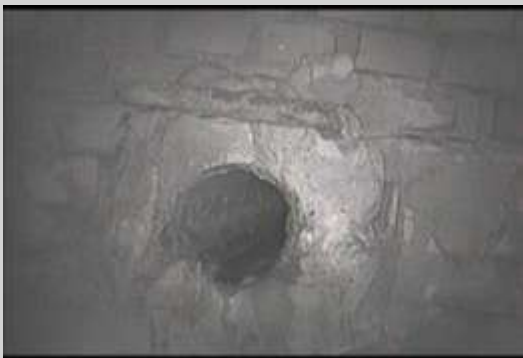
### 6 in. Circular Gravity Sewer Pipe In @ 6 O'Clock

Infiltration: **Evidence** Pipe Seal Cond: **Unknown**

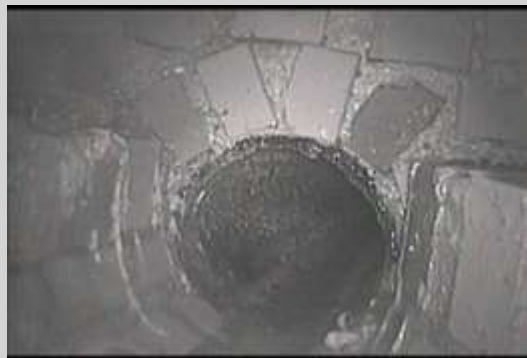
8 in. Circular Gravity Sewer

Infiltration: **Evidence**
